GENERAL DESCRIPTION:

The inspected property consisted of a wood framed two story structure that was vacant at the time of the inspection. The property is a foreclosure and has a considerable amount of interior damage. The approximate temperature at the time of the inspection was 90 to 95 degrees Fahrenheit, and the weather was clear. The utilities were on at the time of the inspection. The buyer's agent was present during the inspection.

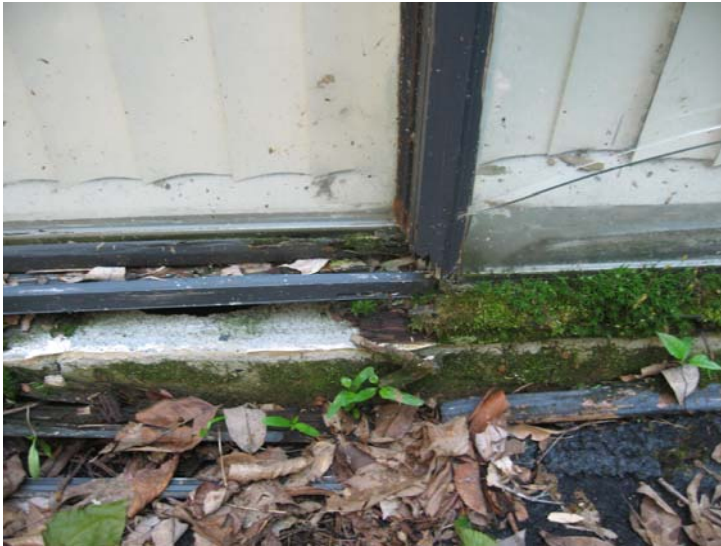
The home is situated on a level to moderately sloped. The general grade around the home was not adequate to direct rainwater away from the foundation. **The right front basement window frame is rotted at the bottom due to water being channeled toward the window.** As an additional precaution against water and / or insect infiltration, it is suggested that landscaping levels be kept 4" to 6" below the siding or masonry veneers. Additionally, trees and shrubbery should be kept trimmed away from the house

- 1. There is a negative pitch on the right side front of the home that needs to be corrected to move water away from the home.***

- 1. Replace missing window screens.***
- 2. The right front basement window frame is rotted. The window needs to be replaced***

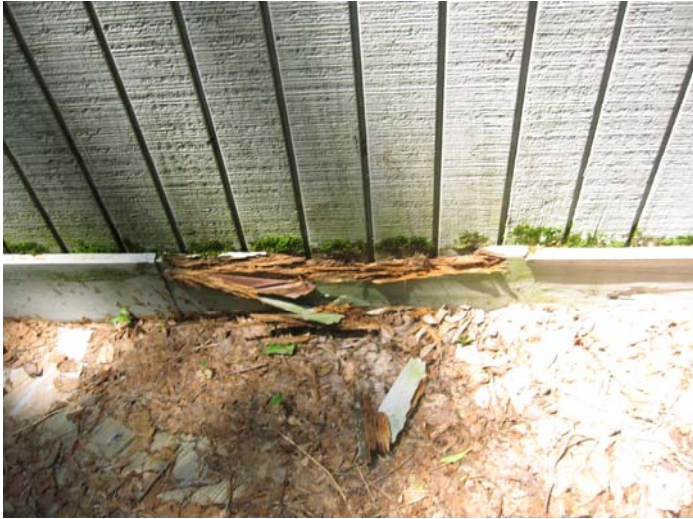
The home is sided with T-111 type panels with wood soffit and aluminum fascia. **The siding along the rear deck appears to be deteriorated. The deteriorated siding has been covered with a facing board which is also deteriorated.** Caulking around window trim and locations where wires or pipes penetrate the siding should be checked periodically to insure that there is no water infiltration.

- 1. Repair or replace the siding as needed.***
- 2. Replace the facing board at along the deck.***

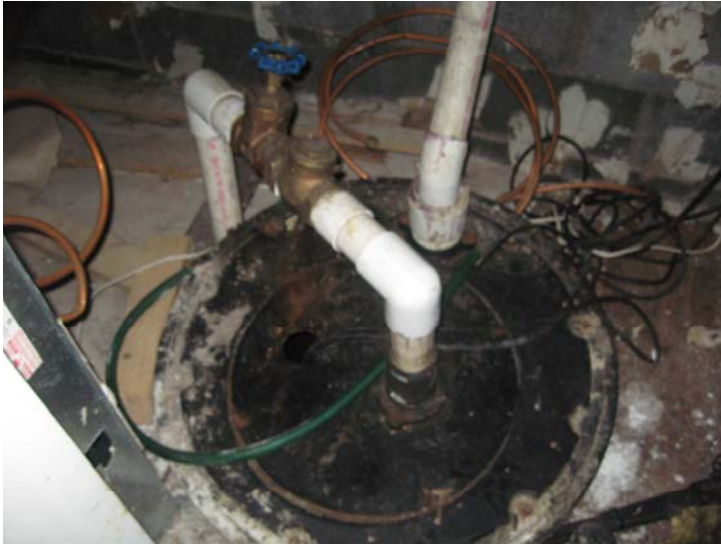
The main water supply line to the home is plastic pipe. The visible water supply lines throughout the home were copper pipe. The water was supplied by a private community water system. The visible waste lines consisted of PVC plastic pipe. The home was connected to a private community sewer system. The domestic water system was turned off after a few minutes due to leaks in various parts of the system.

There is a sewage grinder pump. The pump could not be tested for function because it could not be filled with water.

- 1. Have a qualified plumber check the domestic water lines and repair any leaks.***
- 2. Have a qualified plumber clean and service the sewage grinder pump.***

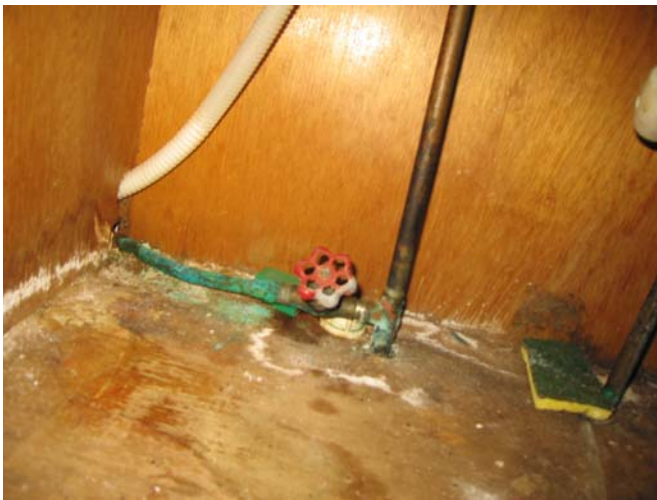
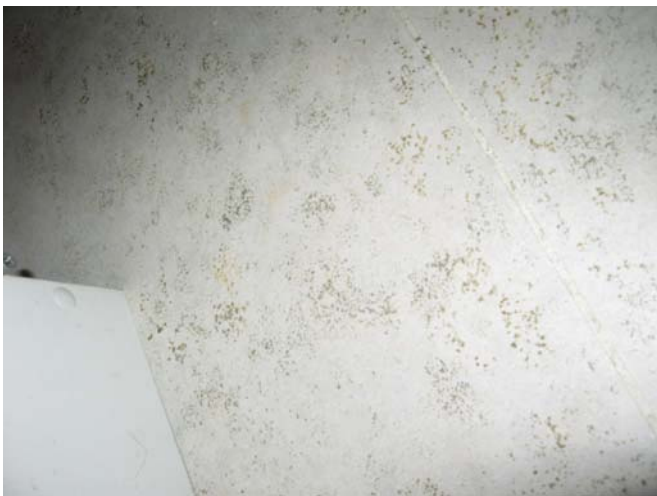
There is visible mold growth in the basement in several locations of the inspected home. Mold can be a health hazard depending on the type of mold and an individuals susceptibility to mold spores. If you are concerned about mold we recommend that the affected areas of the dwelling be tested to determine the type(s) of mold present.
