File Number: **450- 072008 -**

Address of Inspection: **This report is exclusively for the use of:**

The inspected property consisted of a wood framed two story structure that was vacant at the

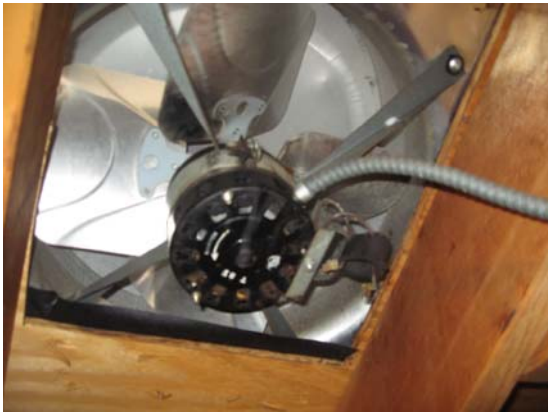
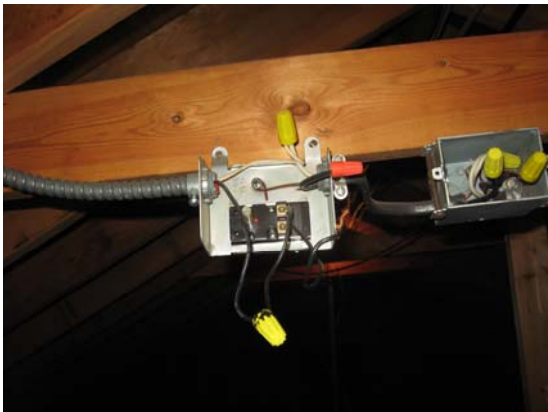
The attic is equipped with a whole house fan. The fan was tested and found to be functional. There is a roof mounted thermostatically controlled exhaust fan. The fan was not functional at the time of the inspection.

- 1. Repair or replace the roof mounted exhaust fan.***

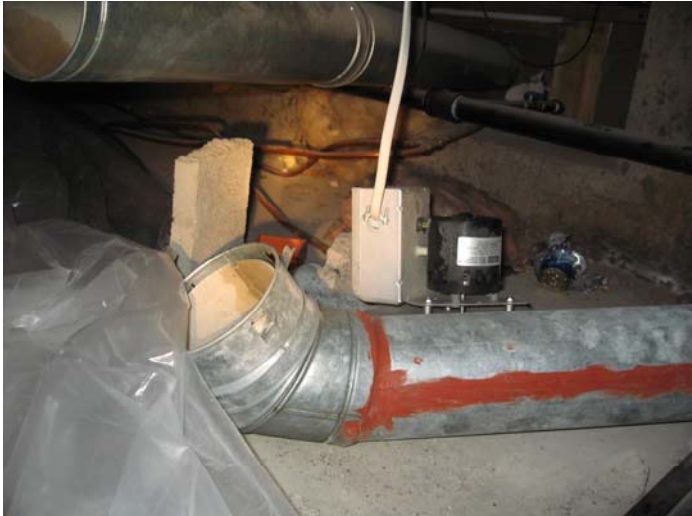
There a non-vented gas log fireplace in the basement family room The fireplace and the metal flue appear to be in good condition, however the direct power vent metal flue pipe is disconnected.

- 1. Follow the manufacturers instruction to clean the electronic air filter.***
- 2. Re-connect the direct power vent to the gas log fireplace in the basement family room***
