PURPOSE OF A HOME INSPECTION:

The inspected property consisted of a wood framed two story structure that was occupied at the time of the inspection. The approximate temperature at the time of the inspection was 80 to 85 degrees Fahrenheit, and the weather was clear. The utilities were on at the time of the inspection. The buyer's and buyer's agent were present during the inspection.

File Number: **450- 062008 – Older Home # 3**

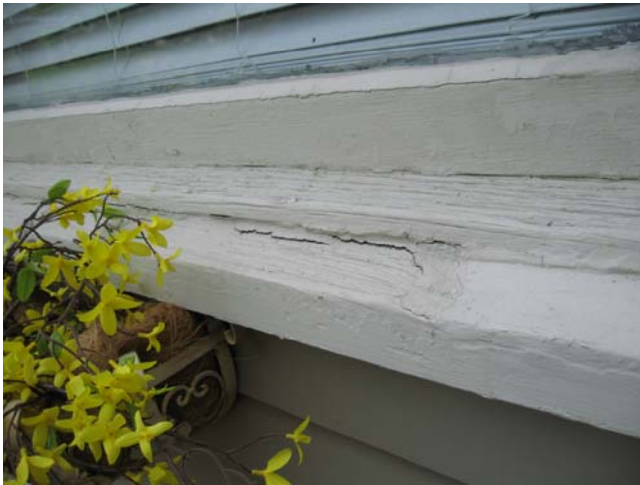
The home is sided with wood with wood soffit and fascia. The siding, soffit, fascia and trim is in fair condition. There are several locations where deteriorated wood has been filled with putty or wood filler and re-painted. Caulking around window trim and locations where wires or pipes penetrate the siding should be checked periodically to insure that there is no water infiltration. There were no major visual defects observed on the siding, soffit or fascia.

- 1. Re-caulk the windows where needed.***

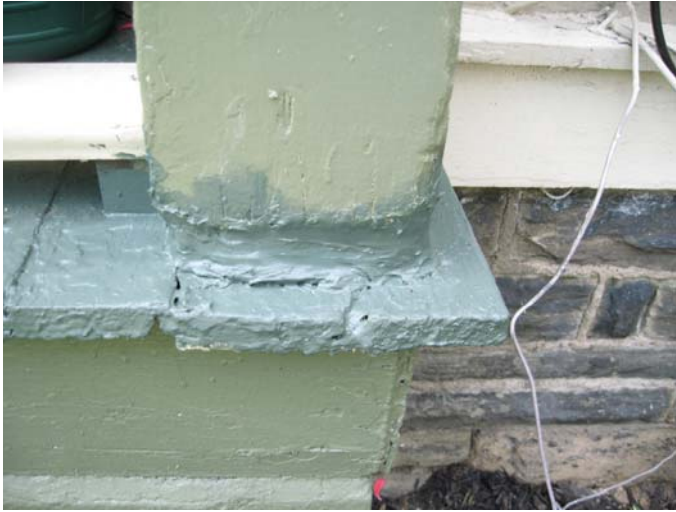
A covered porch constructed of wood extends across the front and partially down the right side of the home. The porch roof is supported by wood posts. The bottoms of the posts appear to be deteriorated and have been filled in with putty and re-painted. There are wood railings around the perimeter of the porch. The porch deck is constructed of tongue and groove flooring. The deck is in fair condition. The porch is accessed by a three rise set of concrete

steps. The steps are in good condition. The steps are equipped with wrought iron hand rails on the right and left sides. There were no major visual defects observed on the porch.

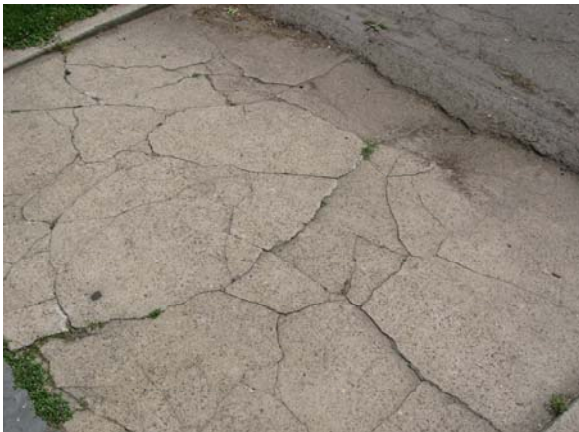
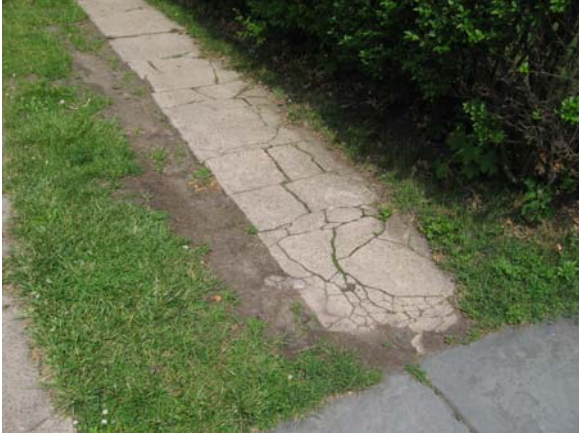
The concrete strip driveway and concrete driveway apron is in poor condition. There is substantial cracking.

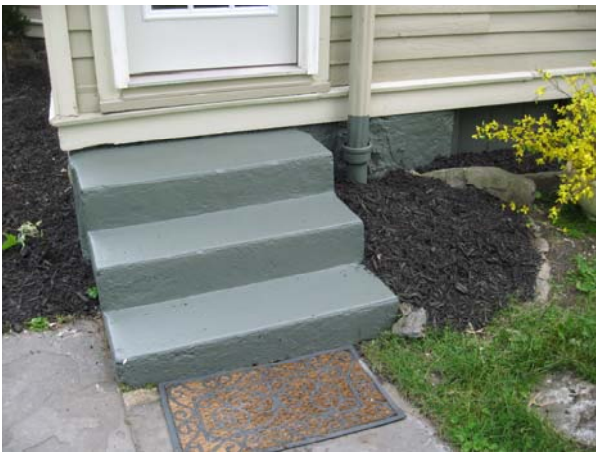
A three rise set of concrete steps that lead to the rear entrance of the home. The steps were not equipped with a hand rail. There were no major visible defects on the steps.

- 1. Install a hand rail on at least one side of the steps.**
