File Number: **450- 062008 – Older Home # 4**

The inspected property consisted of a wood framed two story structure that was occupied at the time of the inspection. The approximate temperature at the time of the inspection was 70 to 75 degrees Fahrenheit, and the weather was clear. The utilities were on at the time of the inspection. The buyer and buyer's agent were present during the inspection.

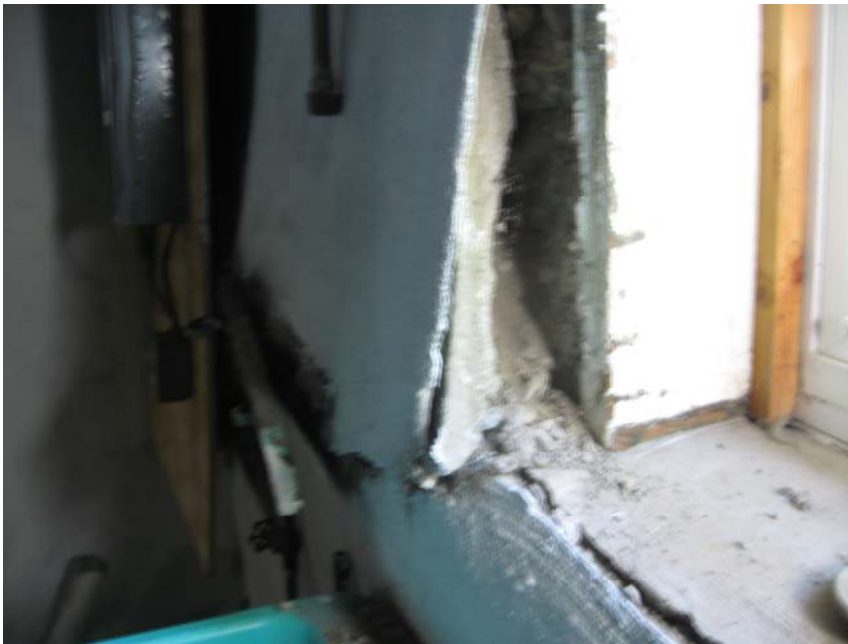
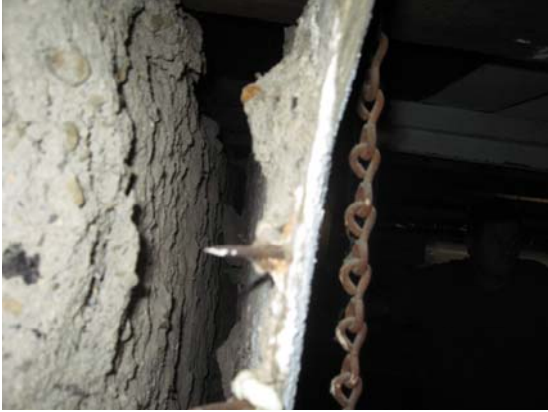
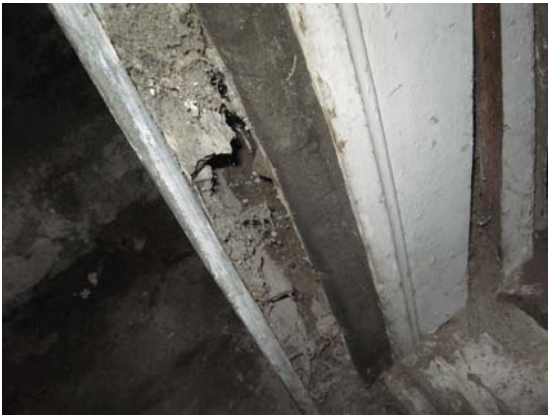
The foundation is constructed of poured concrete. The exterior of the foundation has been covered with cement board and is not visible. The interior visible areas of the concrete foundation, especially the right and left sides, are soft and crumbling. The front half of the right side wall has a block wall built along the interior to contain the crumbling concrete. The remainder of the right wall have cement board nailed to the wall in an attempt to contain the crumbling concrete. The cement board is pulled away from the wall and is fractured in spots.

- 1. We recommend that a qualified masonry contractor inspect the foundation to determine the scope and cost of necessary repairs.***

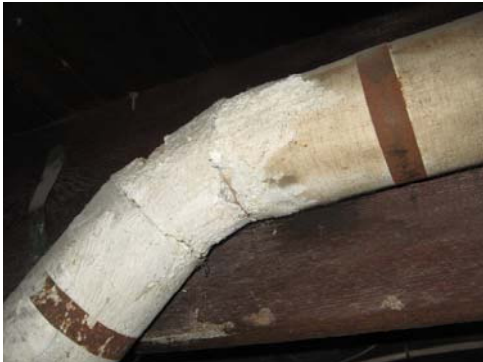
There is an asbestos like material on the steam piping

- 1. Extend the piping from the temperature and pressure relief valve to within six inches of the floor.***
- 2. Clean the base of the chimney.***
- 3. Carefully wrap the asbestos like material with heavy gage aluminum foil and seal with duct tape or have it professionally removed.***
