File Number: **450- 022008 – 0000**
Address of Inspection: **Actual Report – Multi Unit**
This report is exclusively for the use of:

The inspected property consisted of a wood framed, three story, six unit apartment structure that was occupied at the time of the inspection. **There was no access to the first floor, second floor or third floor right side of the apartment building. There is only one access and egress to the third floor apartments.** The approximate temperature at the time of the inspection was 10 to 15 degrees Fahrenheit, and the weather was clear. The utilities were on at the time of the inspection.

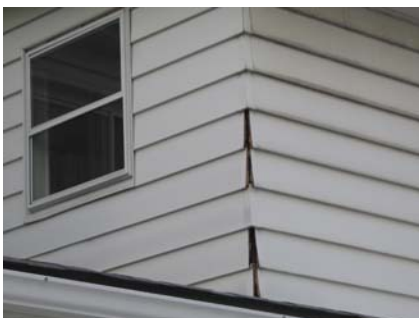
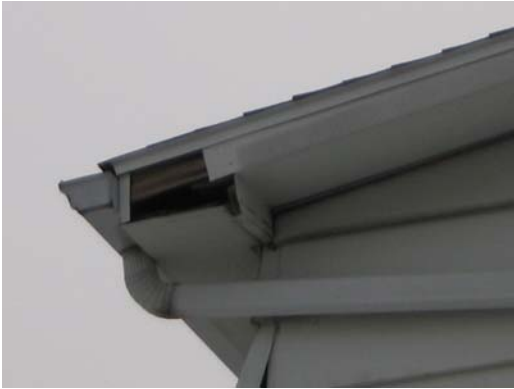
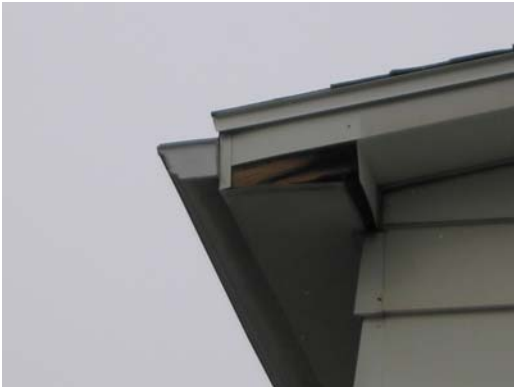
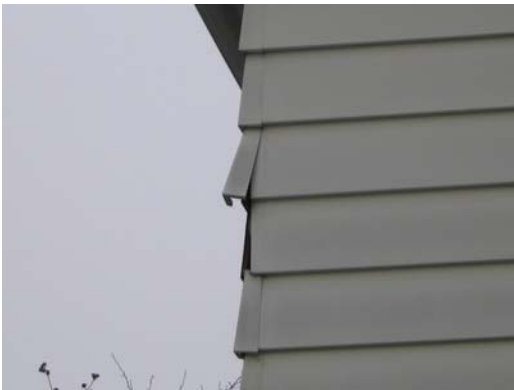
The home is sided with aluminum with aluminum soffit and fascia. There is missing corner trim on the siding at several locations around the perimeter of the home. The cap is missing on the return at the left front of the left side shed roof. The cap is missing on the return at the right rear of the right side shed roof.

- 1. Replace the missing corner trim.***
- 2. Replace the missing return end caps.***

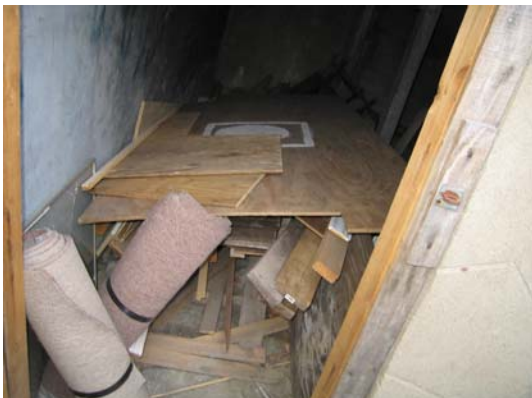
There are enclosed rear stairwells leading to the second floor apartments on both the right and left sides. The right side stairwell has an eight rise set of concrete steps followed by a fifteen rise set of wood steps leading to the second floor. The left side stairwell has an nine rise set of concrete steps followed by a fifteen rise set of wood steps leading to the second floor. The steps are in good condition and are equipped with handrails. There were no major visual defects observed.

1. Remove the debris and stored wood from under the stairwells. It is conducive to wood destroying insects.

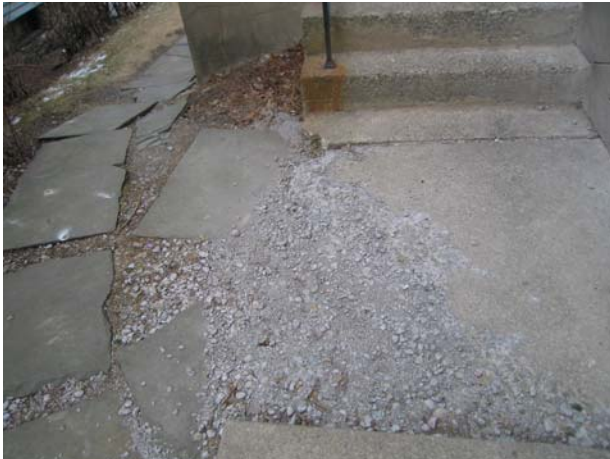
The left walkway is constructed of concrete is in poor condition. There are two broken flags and three badly spalled flags.

- 1. Replace the broken and spalled flags.*

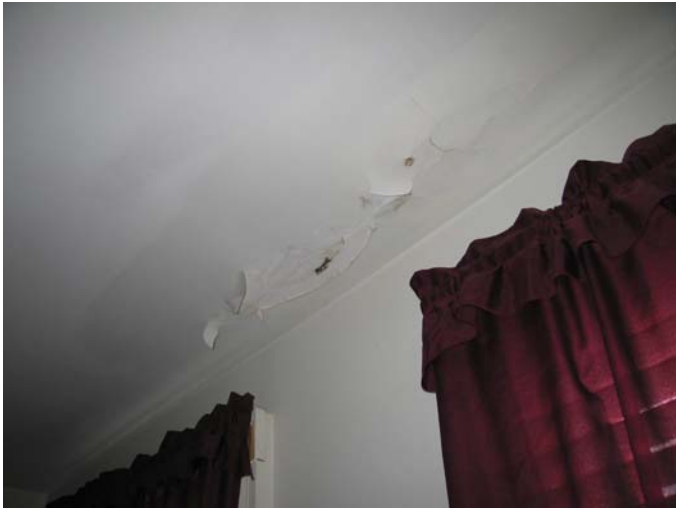
There is an active leak in the front bedroom of the second floor left apartment. The leak appears to be in the vicinity of the third floor exterior alcove. The leak has damaged the ceiling.

The ceilings are drywall and suspended panels in good condition with the exception of the drywall ceiling in the front bedroom. The front bedroom ceiling is stained from an active leak. The walls are drywall and in good condition. The floors are carpeted and in good condition. No major defects were observed in the bedrooms.

- 1. Locate and repair the source of the leak.***
- 2. Repair the bedroom ceiling.***

- 1. Trouble shoot to find the leak in the front bedroom ceiling.***
- 2. Repair the leak and the damaged front bedroom ceiling.***

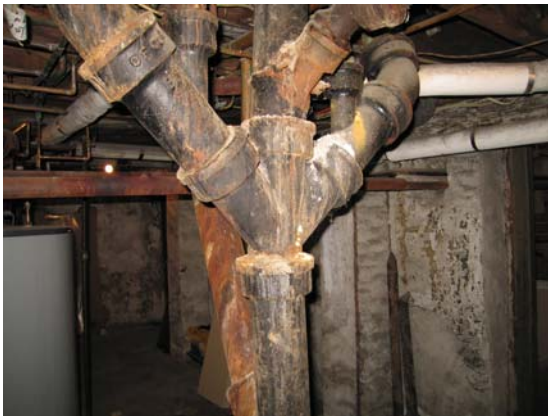
Part of the waste line plumbing is old cast iron pipe. This pipe deteriorates from the inside and can perforate or split at any time without warning. Although **there were no visible leaks at the time of the inspection** we recommend that you consider replacing the cast iron waste lines with PVC plastic pipe in the future.

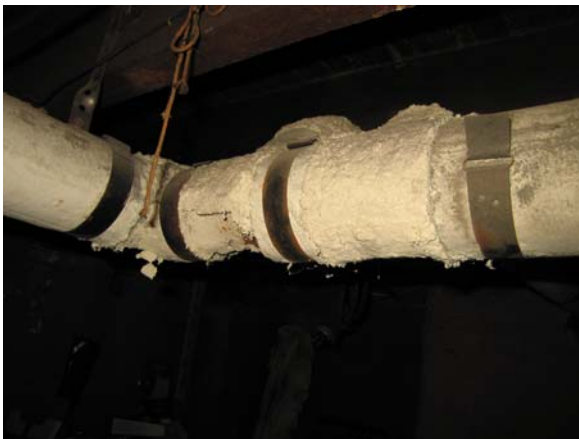
There is an asbestos like material on the steam piping

- 1. Carefully wrap the asbestos like material with heavy gage aluminum foil and seal with duct tape or have it professionally removed.***

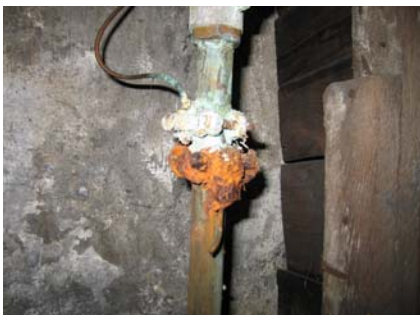
There is some knob and tube wiring visible at the front right of the basement. It appears as if it may be feeding a porch or foyer light. The visible knob and tube is in serviceable condition.

- 1. There are several open junction boxes in the basement that need to have covers installed.***
- 2. Replace the corroded grounding clamp on the cold water pipe.***
