File Number: **450- 072008 -**  
Address of Inspection: **Up & Down Duplex**  
**This report is exclusively for the use of:**

The inspected property consisted of a masonry and wood frame two story up and down duplex structure that was vacant at the time of the inspection. The approximate temperature at the time of the inspection was 75 to 80 degrees Fahrenheit, and the weather was clear. The utilities were on at the time of the inspection. The buyer's agent was present during the inspection.

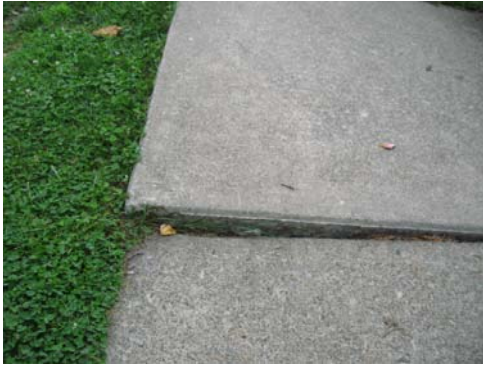
The front sidewalk is constructed of concrete and is in good condition.

1. *Adjust the flags to eliminate uneven edges that create a trip hazard.*
