File Number: **450- 072008 -**  
Address of Inspection: **Up & Down Duplex**  
**This report is exclusively for the use of:**

The inspected property consisted of a masonry and wood frame two story up and down duplex structure that was vacant at the time of the inspection. The approximate temperature at the time of the inspection was 75 to 80 degrees Fahrenheit, and the weather was clear. The utilities were on at the time of the inspection. The buyer's agent was present during the inspection.

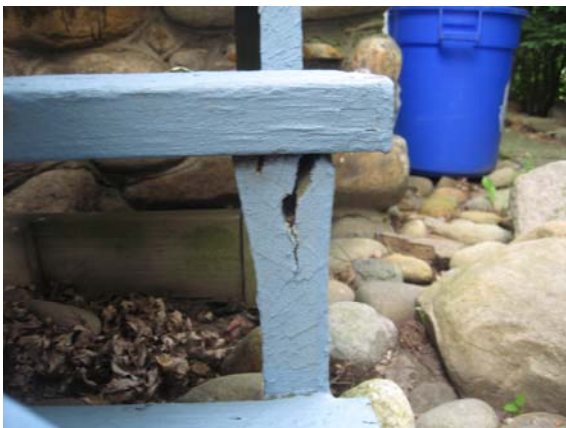
A covered porch constructed of wood with a masonry foundation extends from the left rear entrance of the home. The porch roof is supported by a wood post. There are steel railings around the perimeter of the porch. There is a broken railing post base that needs to be replaced. The porch deck is constructed of 5/4 pressure treated boards. The deck is in good condition. The porch is accessed by a four rise set of wood steps. The steps are in fair condition **with split stringers** where the treads are attached. The steps are equipped with a steel hand rail on the left side. There were no major visual defects observed on the porch.

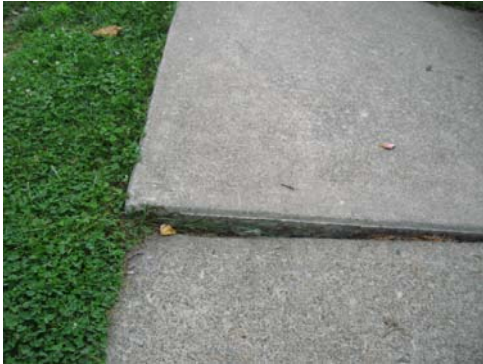
The front sidewalk is constructed of concrete and is in good condition.

- 1. Adjust the flags to eliminate uneven edges that create a trip hazard.*

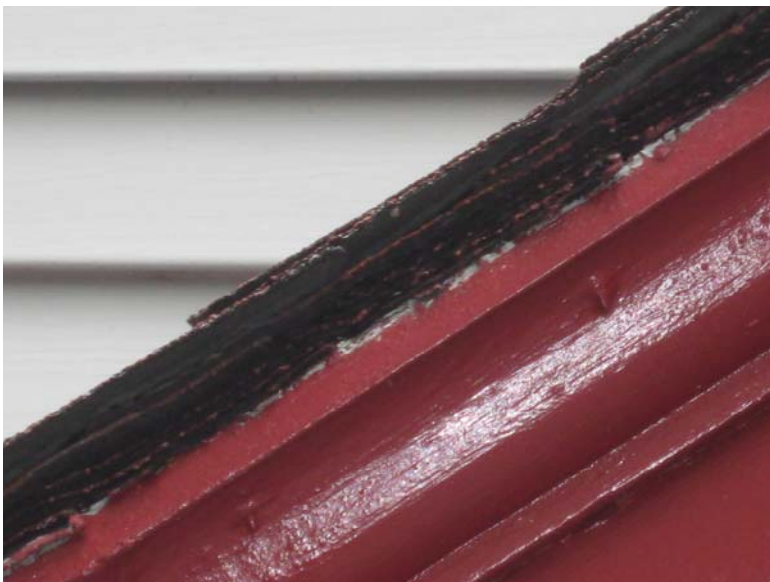
The main roof was a gable style. The roof is covered with asphalt three tab shingles. Observation of the roof surfaces and flashing was performed from the ground with the aid of binoculars. There appeared to be two layers of shingles on the roof at the time of the inspection. It is difficult to determine the number of layers if the shingles have been cut back from the edge and new drip edge installed. There was moderate surface wear and moderate curling observed on the roof shingles at the time of the inspection. These conditions indicate the roof covering was in the last third of its useful life. **The lower rear gable has approximately four layers of shingles.** The rear second level porch roof was not visible. The reported condition of the roof covering is based on a visible observation of the visible roof covering and does not in any way relate to the age of the roof covering. Many factors such as the quality and type of the covering, number of layers of roof covering, the pitch of the roof and how well the attic or space under the roof is ventilated enter into the actual life span of the roof covering.

When new roof coverings are installed, all prior coverings should be removed to inspect the surface of the sheathing. Additionally, the installation of new shingles over a prior layer generally reduces the useful life of new shingles. The installation of drip edge and ice shield are recommended with new installations and attic / roof ventilation should be reviewed for improvement where needed.

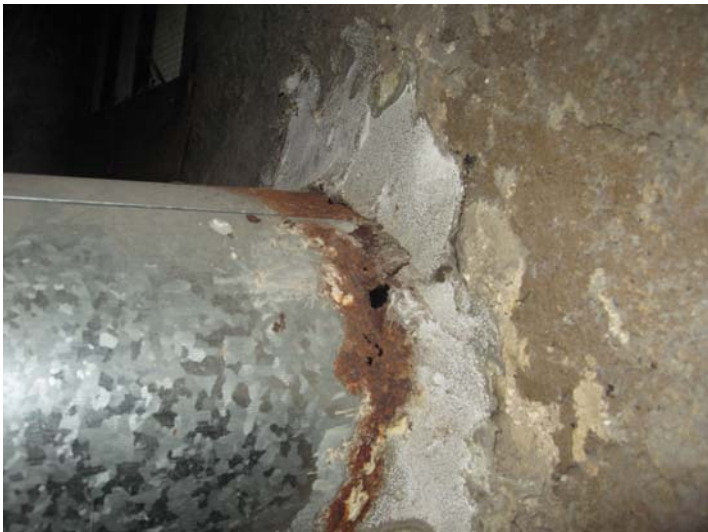
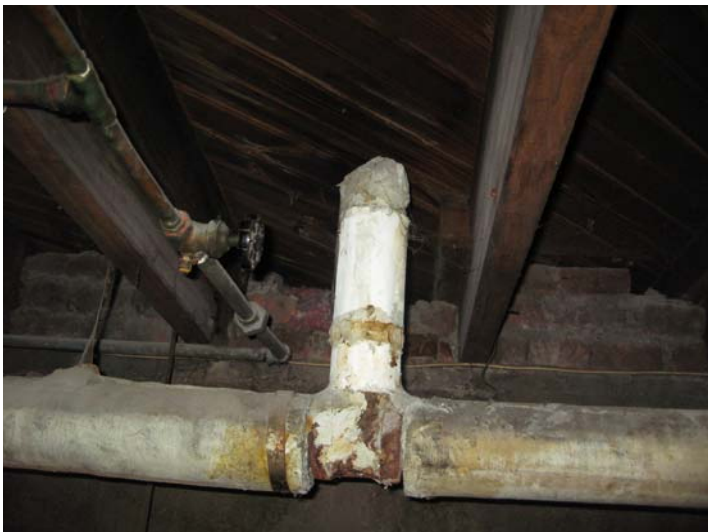
There is an asbestos like material on the steam piping.

The flue piping is rusted out at the chimney and must be replaced.

- 1. Replace the rusted out flue piping.***
- 2. Carefully wrap the asbestos like material with heavy gage aluminum foil and seal with duct tape or have it professionally removed.***

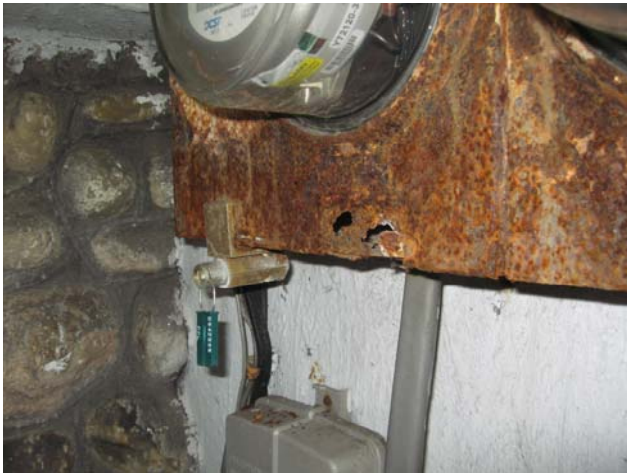
The overhead electric service cable entered the home on the rear wall. The electric meters are located on the exterior wall. **The meter base is rusted out and must be replaced.** The service cables entered (20) slot Square D service panels equipped with 100 AMP main

1. *The rusted out meter base must be replaced.*
