File Number: **450- 072008 -**  
Address of Inspection: **Up & Down Duplex**  
**This report is exclusively for the use of:**

The inspected property consisted of a masonry and wood frame two story up and down duplex structure that was vacant at the time of the inspection. The approximate temperature at the time of the inspection was 75 to 80 degrees Fahrenheit, and the weather was clear. The utilities were on at the time of the inspection. The buyer's agent was present during the inspection.

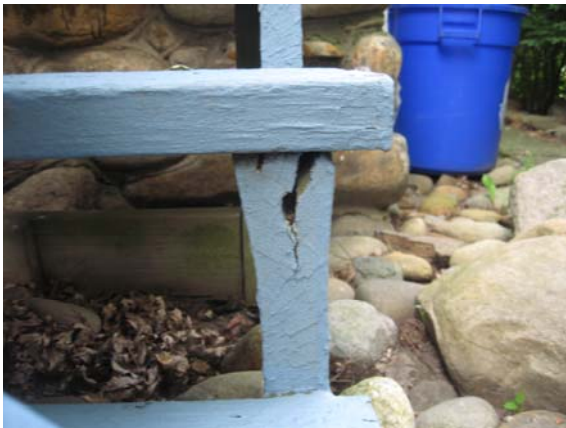
***PORCH -REAR:***

A covered porch constructed of wood with a masonry foundation extends from the left rear entrance of the home. The porch roof is supported by a wood post. There are steel railings around the perimeter of the porch. There is a broken railing post base that needs to be replaced. The porch deck is constructed of 5/4 pressure treated boards. The deck is in good condition. The porch is accessed by a four rise set of wood steps. The steps are in fair condition **with split stringers** where the treads are attached. The steps are equipped with a steel hand rail on the left side. There were no major visual defects observed on the porch.
